Test Certificate

Certificate No.: 70748 K / Stec-Nitz
Page 1 of 1

Item and Test One 8-throw-crankshaft
intended for diesel engine, Type SKL 8 VD 26/20 AL2

Kurbelwelle • crankshaft data sheet

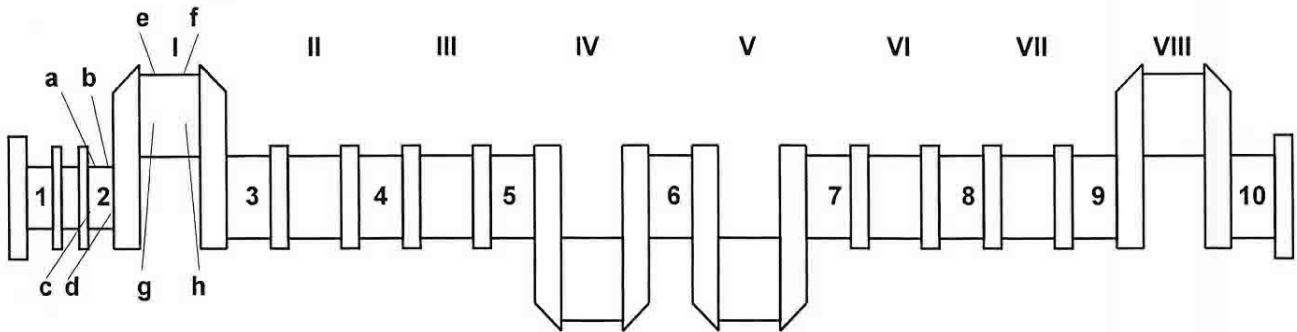
Die Maße c-d und g-h sind an den jeweiligen Zapfen um 90° gemessen. All sizes c-d and g-h are measured on the journals on 90°.

Durchmesser der Grundlagerzapfen						Diameter of Main Journals					Original Ø 180-h6	
NR.	1	2	3	4	5	6	7	8	9	10		
a/b	179,50	179,50	179,49	179,49	179,49	179,49	179,49	179,49	179,49			
c/d	179,49	179,49	179,49	179,49	179,49	179,50	179,49	179,50	179,48			
Rundlauf Alignment												
Härte der Grundlagerzapfen Hardness of Main Journals												
HV												
Durchmesser der Kurbelzapfen						Diameter of Crank Pins					Original Ø 150-h6	
NR.	I	II	III	IV	V	VI	VII	VIII	IX	X		
e/f	149,50	149,49	149,49	149,49	149,49	149,49	149,50	149,50				
g/h	149,50	149,49	149,50	149,49	149,50	149,50	149,49	149,50				
Härte der Kurbelzapfen Hardness of Crank Pins												
HV

Alter Test siehe Rückseite, es wurden keine Risse festgestellt, Abschleiß

Grundlagerzapfen Nr. 1-9 -0,5mm, Abschleiß Kurbelzapfen Nr. 1-8 -0,5mm,

Stützlagerzapfen nur poliert D= 280,06mm, Endflansch plangeschliffen
